## Crack self-healing technology based on bacteria

M.G. Sierra Beltran and H.M. Jonkers\*

*Delft University of Technology, Faculty of Civil Engineering & Geosciences, Section of Materials and Environment, Microlab, Stevinweg 1, 2628 CN Delft, The Netherlands*

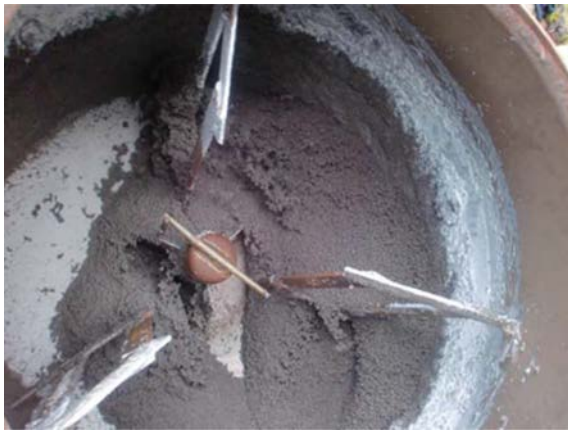
**Fig. 1.** Impregnation on-site of expanded clays with bacterial spores and organic compound as food for the bacteria.

In Ecuador, a section of canal that did not have concrete lining was chosen for the field application. This portion of canal is located at about 2900 meters above sea level. The local farmers, owners and users of the canal, clean the canal section from dirt and vegetation. They prepared the formwork and contributed with the sand and gravel from local extraction. The concrete mix designs were adjusted to the properties of the materials available in the site. The expanded clays were

impregnated with bacteria and nutrients in the field (Fig. 1).

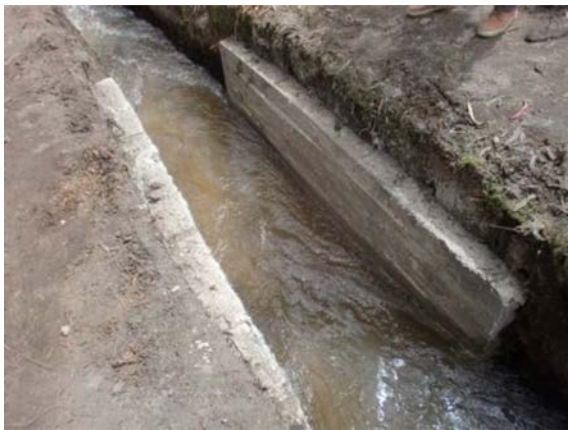
**Fig. 2.** Canal section casted with self-healing concrete (with bacteria) under working conditions only 5 days after casting.

Three days after casting the formwork was taken off and two days later the water flow through the canal was reopened (Fig. 2). After 5 months (December 2014) the concrete linings show no signs of cracking or deterioration as was reported from the last inspection.

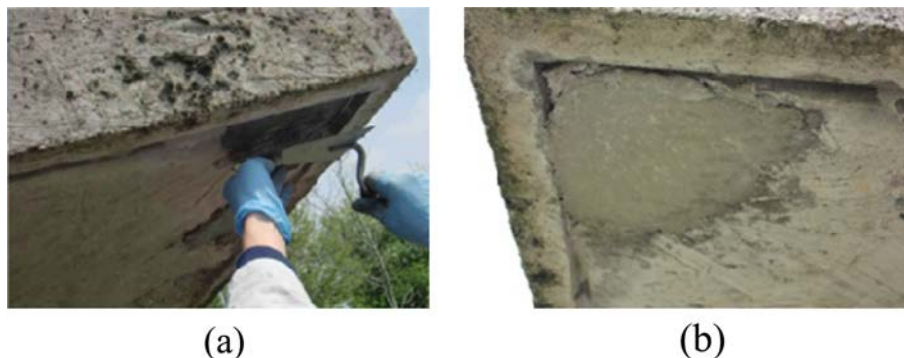
**Fig. 4.** Self-healing mortar applied under dry conditions: (a) fresh state, (b) after 4 months.

The day of casting the temperatures were around 19 °C and during the previous 7 days only 1.3 mm of rainfall were register hence the concrete was dry. In the concrete structure to be repaired, the steel rebar already shown signs of corrosion that lead to the spalling of the concrete. The mortar was placed to completely cover the steel rebar and even the concrete surface (Fig. 4(a)). After 4 months the site was inspected and no signs of cracks were seen. After 1.5 years the patch repair is in good conditions without deterioration (Fig. 4(b)).

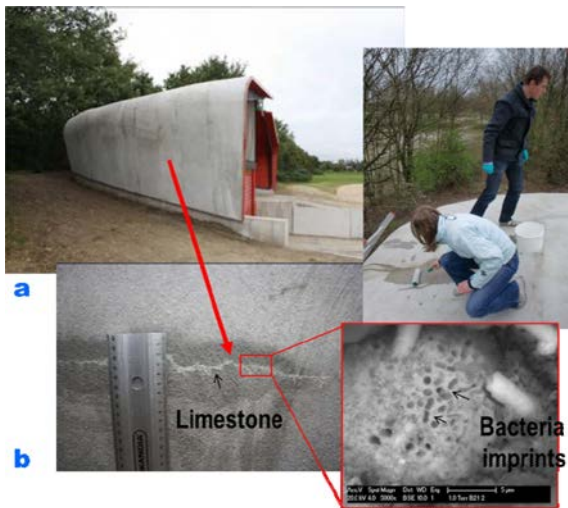
**Fig. 8.** Cracked concrete structure and crack sealing after impregnating with liquid-based repair system.

In 2012 the first field application of the liquid-based system took place. A recently built structure in Breda showed multiple micro-cracks and during a rainy period water leaked into the building. The system described in section 4.1 was applied as shown in Fig. 8.

Within days the leakage of water dramatically decreased. A few months later core samples were taken to analyse the apparent crack sealing.
