A Study on the reinforced CFS using the concept of self-healing repair methods in bottom side for damaged highway RC slabs

Key words: RC slabs, Reinforcement, CFS, Deterioration, Self Healing Materials, Self-healing repair methods

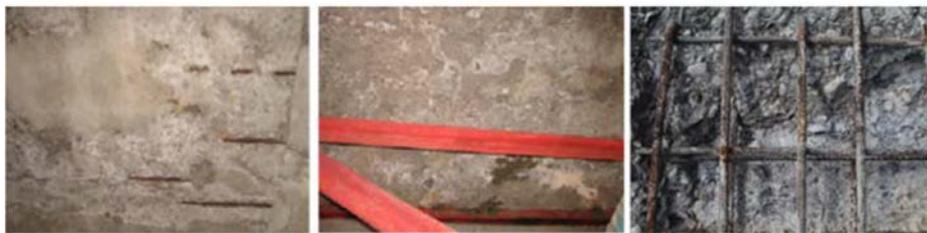
Fig. 2. Important route of coastal areas.

The damage shown in Fig. 2 is on a major route in the vicinity of the shoreline, and the majority of damage is salinity from salt in the air. As shown in Figs. 2(a) and (b), the rebars are exposed and rust caused by leakage from the cracks is present.

(a) Rebar leakage (b) Deposition of rust (c) Rebar leakage and Rust

The damage shown in Fig. 2 is on a major route in the vicinity of the shoreline, and the majority of damage is salinity from salt in the air. Thus, rebars are exposed and rust caused by leakage from the cracks is present. Therefore, the damage can be classified as d, and the deterioration process seems to be at the acceleration stage (the late period)

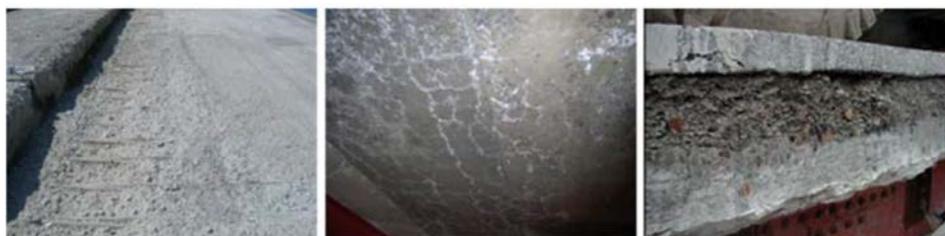
Fig. 3. Cold and snowy region.

Fig. 3 shows damage of an RC slab of a highway bridge built on the cold front. Despite the small amount of traffic, including both heavy and private vehicles, serious damage can be observed, which was caused by freezing and thawing and the spread of chloride. Fig. 3(a) shows damage caused by repeated vehicle travel; many fine cracks and scaling can be observed on the concrete cover. Fig. 3(b) shows the undersurface of Fig. 3(a), showing glass petrification of the cement material caused by leakage through cracks on the surface, and a crack has occurred in two directions. In Fig. 3(c), despite the well reserved surface, it is gravel from the concrete cover below compressive strength

(a) scaling (b) Cracks and Free lime (c) gravel of internal

due to a combination of factors such as frost damage from repeated freezing and thawing and chloride spread. The example slab is from a bridge demolished after 30 years of public use. The common factor in the RC slab damage mentioned above is that the cracks are made in one or two directions and composite damage was caused by the intrusion of seepage water through the cracks. Thus, the root cause of composite damage is cracks, and the use of the concept of self-healing repair method in reinforcement methods seems to be an appropriate early countermeasure in terms of prevention and maintenance. Thus, adding the concept of self-healing repair methods as a countermeasure for cracks is necessary not only for new concrete but also during maintenance and reinforcement, and further research on integrative maintenance and reinforcement for composite damage using self-healing material is required.

Fig. 3 shows damage of an RC slab of a highway bridge built on the cold front. But, serious damage can be observed, which was caused by freezing and thawing and the spread of chloride despite the small amount of traffic. Fig. 3 (a) and Fig. 3 (b)'s damage can be classified as e, and the deterioration process seems to be

at the deterioration stage, where reinforcement is not possible.

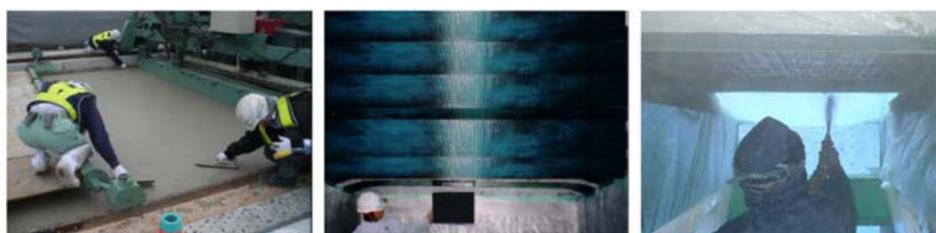
Fig. 4. The main reinforcement measures.

Currently, most commonly used RC slab reinforcement measures can largely be divided into upper surface reinforcement and undersurface reinforcement. The major construction methods of these reinforcement measures can be seen in Fig. 4 [5].

The method shown in Fig. 4(a) is the upper surface pressure method using Steel Fiber Reinforced Concrete (SFRC) for reinforcement, which is used to increase the load-carrying capacity and fatigue resistance in cases where the RC slab surface is seriously damaged. In recent years, in order to improve adhesion, methods such as the application of epoxy resin or combustion using water shot-blasting have been added to the SFRC upper surface pressure method. The method shown in Fig. 4(b) is an undersurface adhesive method using CFS, with high constructability, which is mainly used to slow down deflation, reduce stress intensity, restrain crack formation, and improve fatigue lifespan. Fig. 4(c) shows an undersurface pressure method using mortar spray. In this method as well, recent studies have investigated methods to improve adhesion by the application of epoxy resin, combustion using water shot-blasting, or using steel made of carbon fiber.

(a) SFRC overlay (b) CFS bottom side Reinforcement (c) spraying method of mortar
