## Investigation of natural crack healing phenomena on historical masonry mortars

Cementitious materials have been often observed for many years to have a natural crack healing capability due in part to the re-hydration of previously unhydrated cement within the matrix upon re-submersion in water. However, the natural phenomena such a crack self-healing is very limited, because self-healing capability of crack depends on various environmental conditions. This study aims to clarify the natural healing phenomena of crack in cementitious materials and develop crack self-healing cementitious materials based on the natural healing mechanisms. In this research, secondary phases of newly-formed products in historical masonry mortars were investigated in old bridges in the Netherlands. Moreover, in order to understand the precipitation conditions of calcium salts in the cracks, morphology, the shape and size of re-hydration products in the old mortar and brick, microscopy and SEM (EDS) analysis were also conducted. From these results, modified C-A-S-H phases as well as the formation of calcite were found, which increase the self-healing capability of old masonry mortar by both dissolution

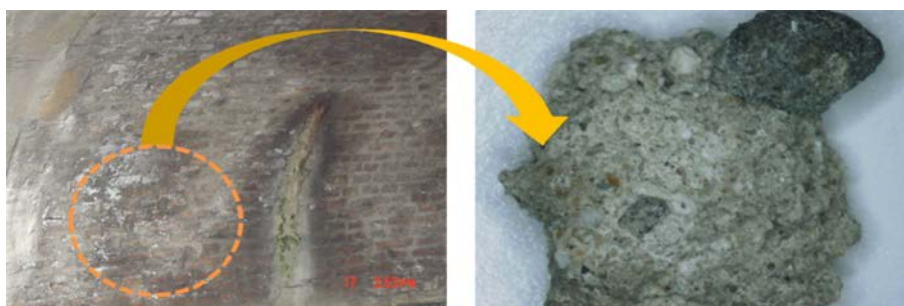
**Fig. 2.** Mortar sample with the secondary phases from brick arched bridge.

Fig. 2 shows a sample of secondary products on the surface and in the cracks of the mortar between the old bricks. It was found that white secondary products were formed on the mortar surface. Microscopy analysis is shown in detail in Fig. 3.

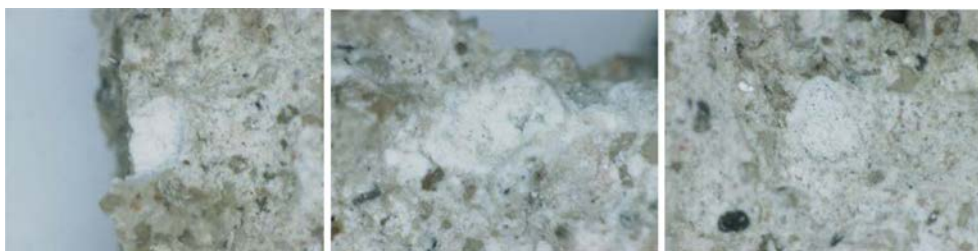
**Fig. 4.** Microphotograph showing newly-formed porosity for the supplying  $\text{Ca}^{2+}$  source.

The microscopy image shows that most of the cracks were fully filled by newly-formed hydration products. It seems that these are precipitated  $\text{CaCO}_3$  composites. However, Fig. 4 shows what appears to be new porosity generated in this system. T. Nijand reported

this phenomenon as follows: when crack self-healing occurs at one location, if the  $\text{Ca}^{2+}$  source is not enough for the formation of new phases, there is the potential for the generation of new porosity at other locations in order to supply  $\text{Ca}^{2+}$  source [6]. In other words, formation of secondary phases depends on the  $\text{Ca}^{2+}$  source conditions. Therefore, the addition of lime for supplying an additional  $\text{Ca}^{2+}$  source might be considered as one methodology for self-healing.
